RAILWAY INVESTIGATION REPORT

R03T0047

YARD COLLISION

**CANADIAN NATIONAL
TANK CAR PROX 77811
MILE 25.0, YORK SUBDIVISION
TORONTO, ONTARIO
22 JANUARY 2003**

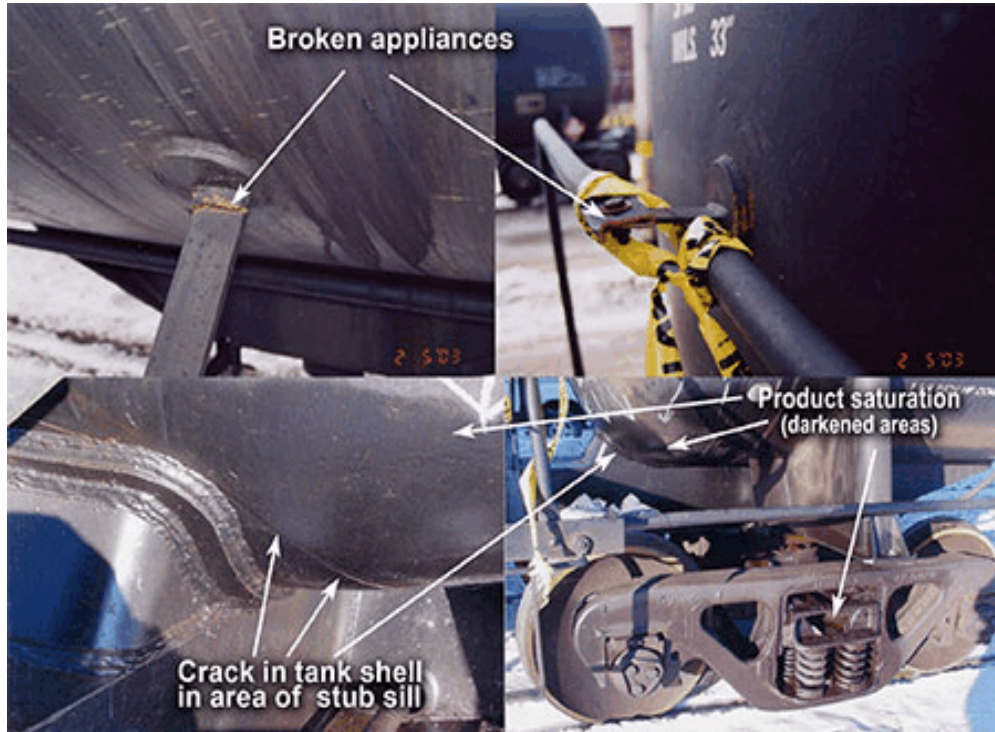
A post-incident examination of the tank car determined that there was a 20-inch crack in the tank shell at the A-end of the car in the area of the stub sill (see Photo 1). In addition, there were numerous broken safety appliances at the A-end.

Photo 1. Damage to tank car PROX 77811 shell and appliances

A portion of the tank shell, which included the crack, was cut from the tank car and sent to the Transportation Safety Board of Canada (TSB) Engineering Laboratory for analysis. The examination (report LP 048/2003) determined that there was a pre-existing crack in the tank shell that had been present for a considerable length of time, likely initiated during welding. During the service life of the tank car, it had been subjected to normal service loads without previously failing.

A pre-crack was present in the tank shell of car PROX 77811. This pre-crack, which was likely initiated by welding, may have existed since the initial construction of the car in 1969. Despite the presence of this pre-existing crack and the many years of revenue service for this tank car, it is likely that the final fracture of this crack was caused by a high-impact load from an overspeed coupling.

1. The cracked tank shell and subsequent loss of the product from car PROX 77811 was likely caused by the final fracture of a pre-existing crack in the stub sill area following a high-impact load from an overspeed coupling.
2. On the day of the occurrence, tank car PROX 77811 had been incorrectly categorized as a non-regulated empty rail car in the hump process control system (HPCS), thereby allowing it to be released from the hump as a two-car movement with a target coupling speed of 7 mph rather than 6 mph.
3. After the humping operation on 22 January 2003, when the coupling speed was estimated to be 13.54 mph, tank car PROX 77811 was not identified as being involved in an overspeed coupling, allowing it to continue in service without a mechanical inspection and resulting in the subsequent loss of the product.
